**Coseismic and monsoon-triggered landslide impacts on remote trekking infrastructure,
Langtang Valley, Nepal**

Short title: Landslide impacts in Langtang, Nepal

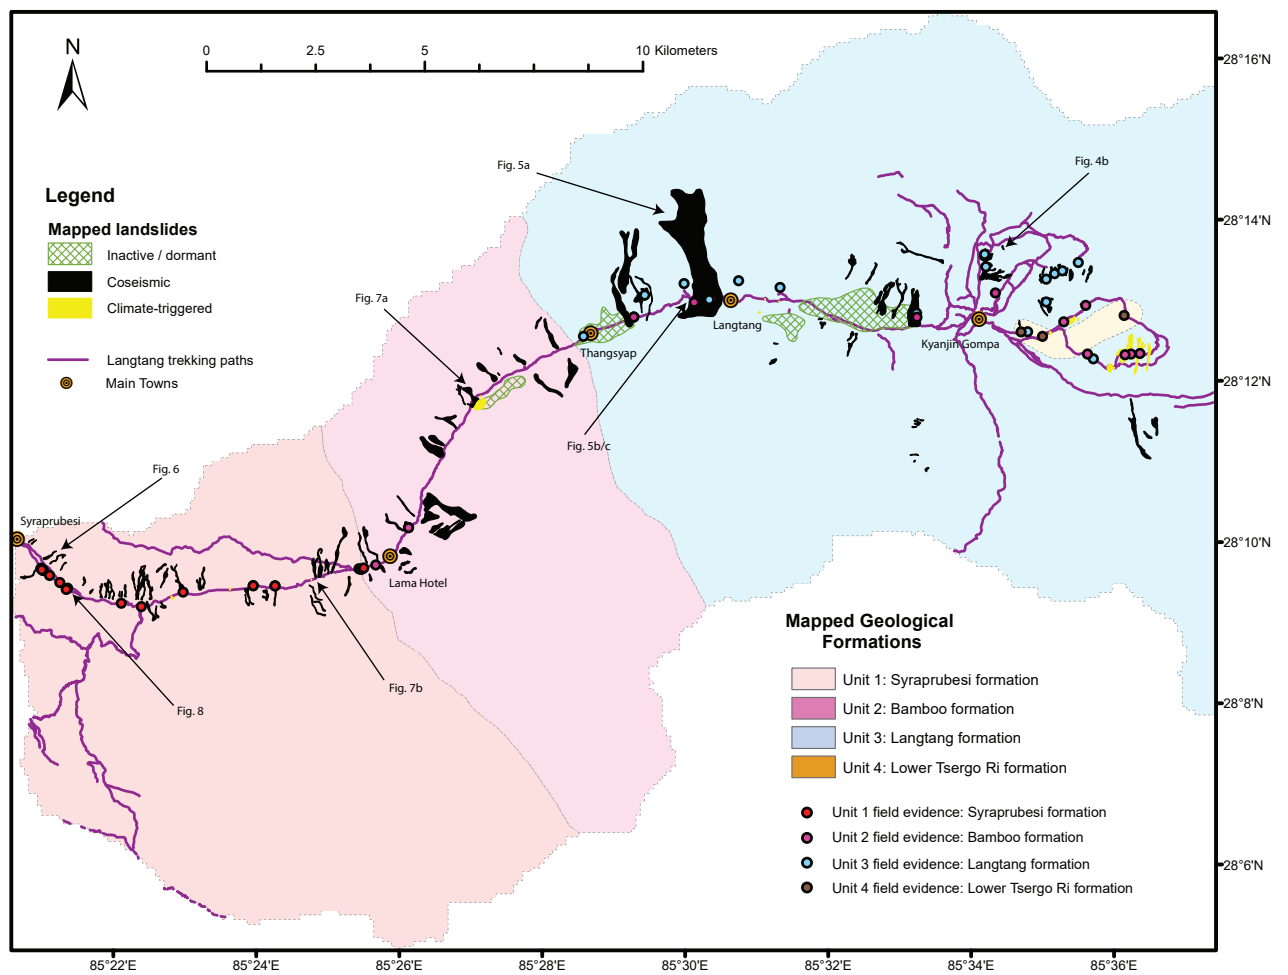
Fig. 2. Map of the lower portion of Langtang Valley that was the focus of the fieldwork. The main geological unit observations and estimated extents, towns, trekking routes and mapped landslides are displayed. The locations of the landslides in figures 4-8 are also highlighted.

Field data collection occurred along the main trekking routes in Langtang Valley between Syaprubesi and Kyanjin Gompa, a total distance of approximately 50 km (Fig. 2). An inventory including both coseismic and monsoon-triggered landslides was developed using a GARMIN 78 hand-held GPS unit

Geological assessments also documented non-land slipped outcrops for strength comparison. Locations of lithological analysis are shown in Fig. 2. These locations informed the geological map compilation (Fig. 2), where the outcrop pattern is interpreted using topographic contours. Other mapping involved using GPS and remote sensing to delineate pre- and post-earthquake path locations.

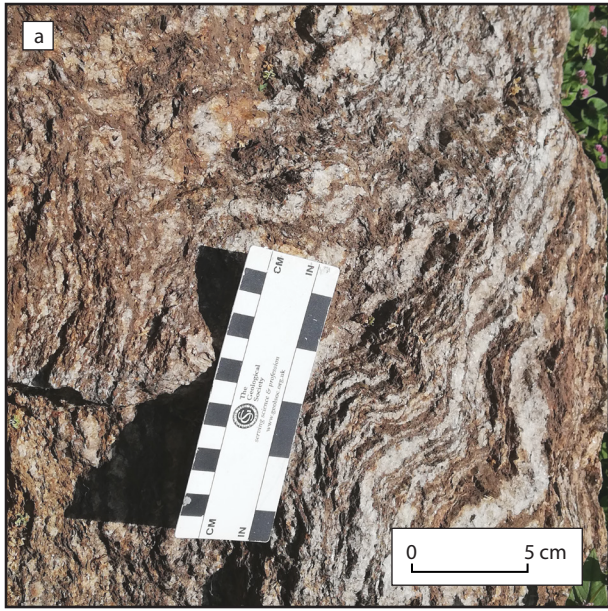
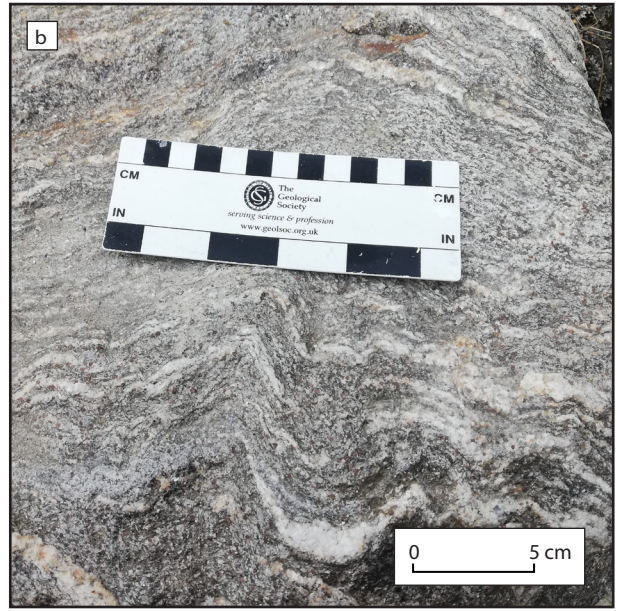
Fig. 3. (a) Example material of unit 1, a muscovite, biotite, plagioclase, quartz, garnet gneiss, termed here as the Syraprubesi Formation. Note the strong mylonitic fabric. **(b)** Example material of unit 2, a muscovite, biotite, plagioclase, quartz, tourmaline gneiss, termed here as the Bamboo Formation. Again, note the strong mylonitic fabric, and the dominance of quartz and biotite.

Four lithological units were identified within landslides across the valley. The first unit, termed here as the Syraprubesi Formation, is a gneiss dominated by muscovite, biotite and quartz, with subordinate components of plagioclase and garnet (e.g. Fig. 3a). This unit is medium- to coarse-grained, with average grain size of 0.3 – 3 cm. The minerals were generally platy, with elongated plagioclase orientated parallel to foliation and a strong mylonitic fabric. *In-situ* strength tests indicate that this unit

is hard (50 – 100 MPa). The second unit, the Bamboo Formation, is a gneiss dominated by muscovite, biotite and quartz, with subordinate components of tourmaline (e.g. Fig. 3b). This unit was very similar to unit one, but with a larger average grain size of 1 – 3 cm, and with the addition of tourmaline. Unit two had a much higher proportion (60 – 70 %) of quartz and biotite compared to unit one, but maintained the mylonitic fabric. Strength tests suggest that unit two is very hard (100 – 250 MPa). Unit three, named the Langtang Formation, is a coarse-grained (2 – 6 cm) leucogranite, dominated by muscovite, tourmaline, epidote, and occasionally garnet (e.g. fig. 4a). Unit three was commonly found intruded into units two and four, and has a strength of 50 – 250 MPa. This unit was often observed in the source zones of earthquake triggered rockfalls (e.g. fig. 4b). We hypothesize that the discontinuities induced by the intruded leucogranite dykes and sills have reduced the shear strength of the bedrock, making failures in regions with this unit more likely. Unit four, termed here the Lower Tsergo Ri Formation, is a biotite, plagioclase, muscovite, quartz, semi-pelite schist (e.g. fig 4c). This unit was finer grained than the other units (average grainsize 0.25 – 1 cm) and had an estimated strength of 100 – 250 MPa. This unit was dark to light grey in colour and was frequently observed to be in contact with leucogranite.

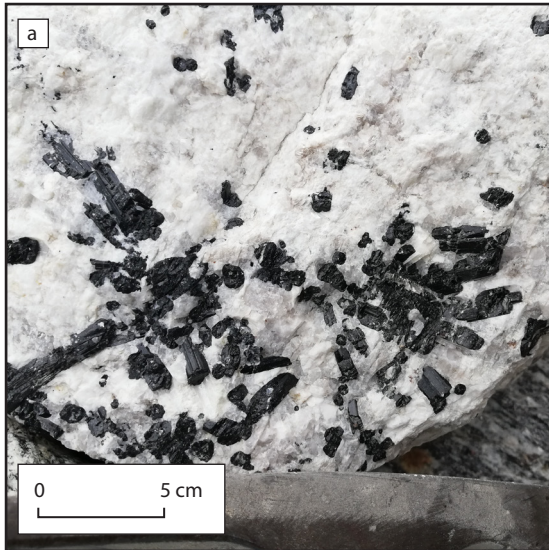
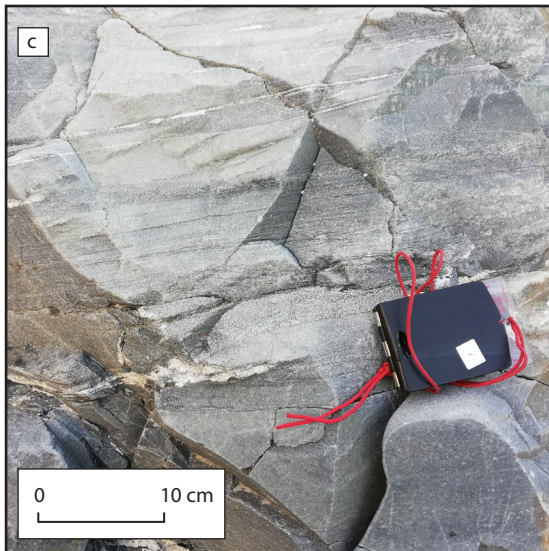
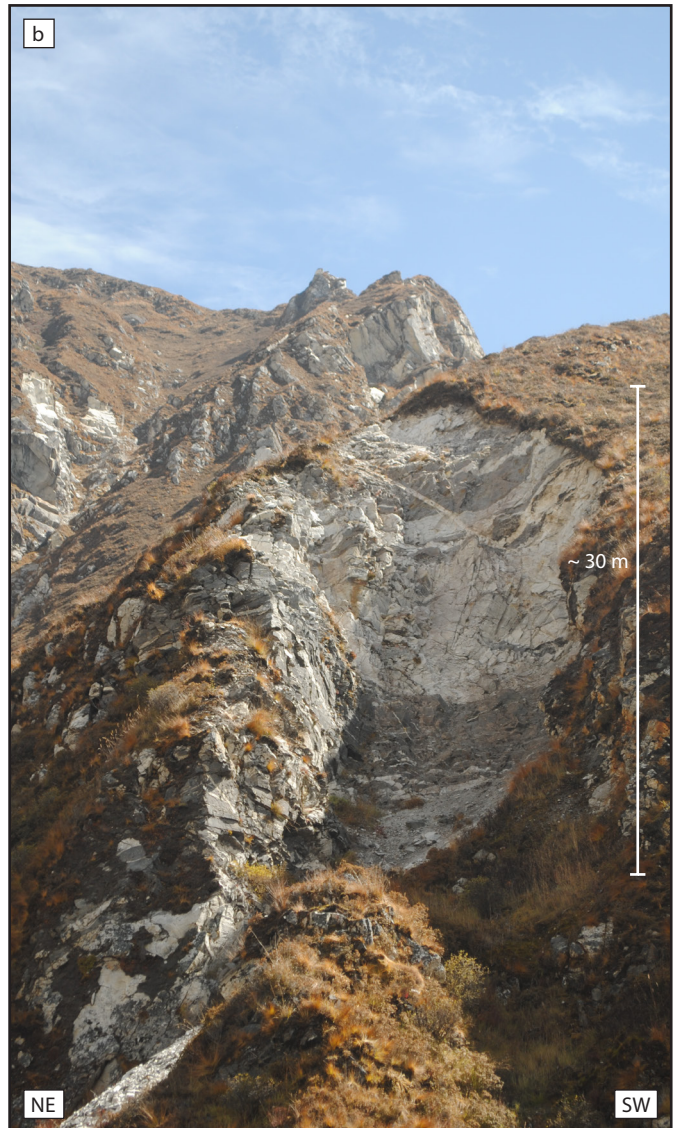
Fig. 4. (a) Example material of unit 3, a leucogranite with large, 1 – 5 cm, crystals of tourmaline, termed here as the Langtang formation. **(b)** A typical rockfall found in the eastern, higher elevation portions of Langtang Valley, with large intrusions of leucogranite within the bedrock of the scar. **(c)** Example material of unit 4, a finer grained, 0.25 – 1 cm, biotite, plagioclase, muscovite, quartz, semi-pelite schist, termed here as the Lower Tsergo Ri Formation.

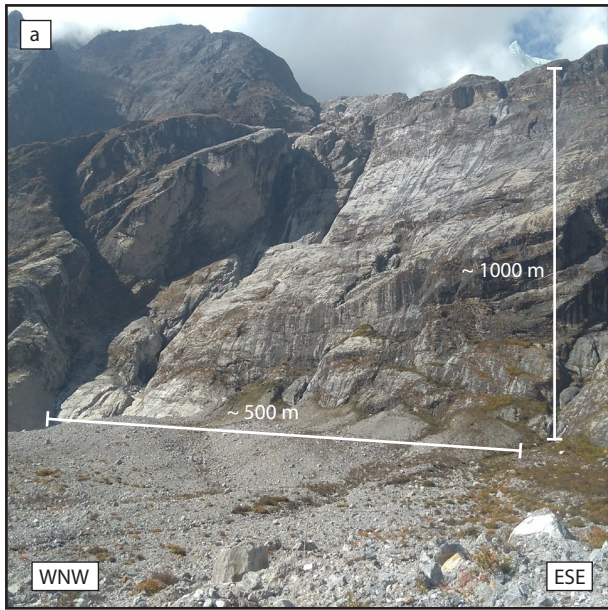
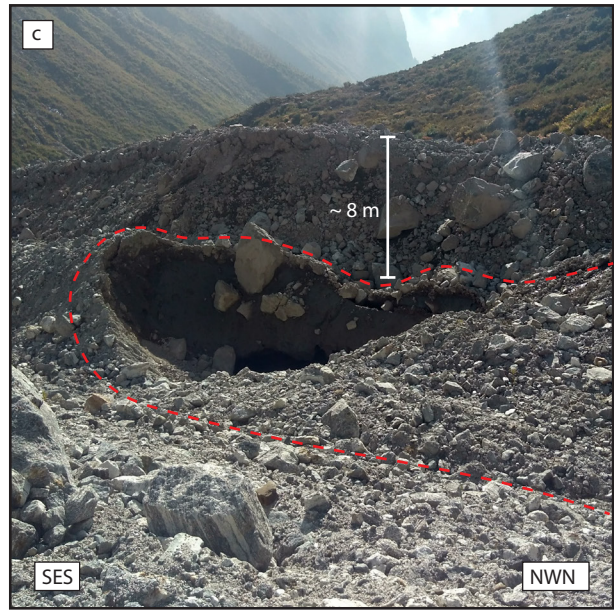
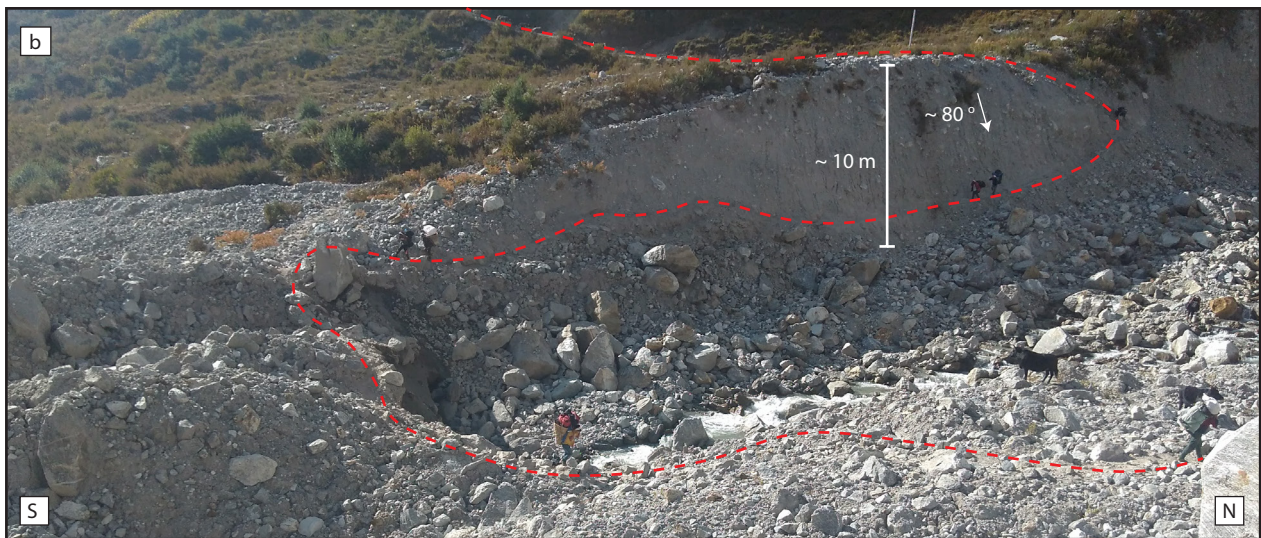
Fig. 5. (a) Front view of the Langtang Avalanche. Note the clear striations on the relatively smooth back-scar and change in slope of the back-scar which is indicative of a rotational element of movement. **(b)** A section of the Langtang Avalanche deposits that have been incised by a river. The precarious location of the new trekking route is shown by the red-dashed line. **(c)** A tunnel incised underneath the landslide deposits by a river. Red line indicates the current position of the trekking path over the top of the tunnel.

The Langtang Avalanche is perhaps the most renowned coseismic landslide to have occurred during the Gorkha earthquake, having entirely destroyed the village of Langtang with the loss of at least 300 lives. This event was a complex compound occurrence that began when earthquake strong ground motion caused a portion of glacial material within an ice-carved hanging valley, as well as a portion of bedrock approximately 500 x 1000 m in size (Fig. 5a), to collapse (Nagai *et al.* 2017). The deposits from this event have been previously estimated through remote sensing techniques to have a depth of ~60 m, an area of 0.63 – 0.88 km², and a volume of 5.51 – 9.66 x10⁶ m³ (Lacroix 2016; Nagai *et al.* 2017). Pertinent to this study is the interaction between the landslide deposits and trekking paths. This event completely buried a ~ 500 m long section of the main trekking path, which has since been reinstated over the landslide deposits. The material within the deposits is mostly gneisses (unit 2) and leucogranites (unit 3). Fig. 5b shows the position of the new trekking path at the point where a river has incised through

the deposits. The path here is highly precarious, with some sections < 30 cm wide beneath a > 80 °, 10 m high slope of loose deposits, which are vulnerable to movement during a future trigger event. Furthermore, the path crosses over a narrow tunnel that has been created by the river (Fig. 5c). This portion of the deposits is unstable, and several boulders were witnessed falling from beneath the tunnel into the river. This demonstrates that the Langtang Avalanche is continuing to impact the safety and vulnerability of Langtang's trekking paths more than three years since the initial failure occurred.

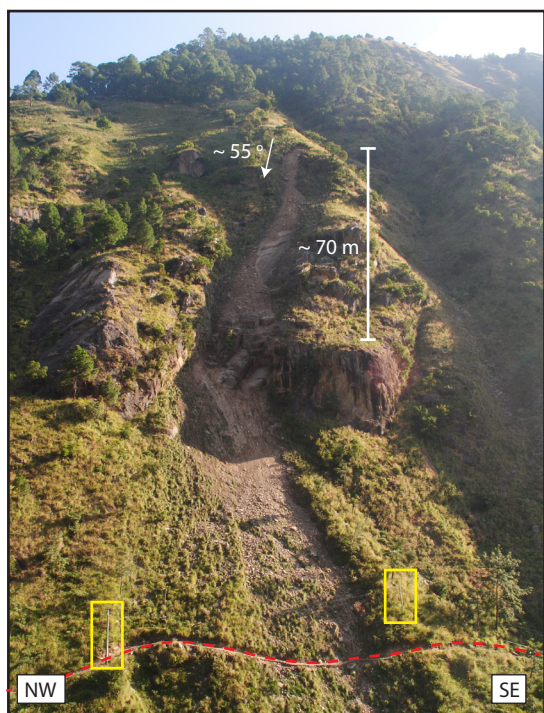
Fig. 6. Debris slide located ~4 km east of Syraprubesi. Red-dashed line indicates the main trekking path that has been impacted by the failure. The yellow boxes indicate the position of electricity / telegraph poles.

Whilst the Langtang Avalanche has undoubtedly had the greatest single impact on trekking infrastructure, the cumulative impacts of smaller, but more widespread, coseismic failures cannot be understated. For example, coseismic debris slides were pervasive along the lower, western portion of the valley. Fig. 6 shows a debris slide that initiated near the ridgeline of a > 55° hillslope covered by grassland in the lower slopes and trees and larger shrubs in the upper slopes. The bedrock geology of the scar of this failure is dominated by the gneisses of unit 1. However, as the failure is shallow (< 0.5 m), and has mostly disturbed the unconsolidated regolith material overlying the bedrock, it is defined as a debris slide rather than a rockslide. In terms of impact on trekking infrastructure, the localised runout of this failure resulted in only a small volume of material intersecting the path. However, more concerningly, it was observed that this debris slide came close to damaging several electricity pylons. These pylons connect to the new hydropower station near Kyanjin Gompa, and are a vital component of Langtang's energy infrastructure.

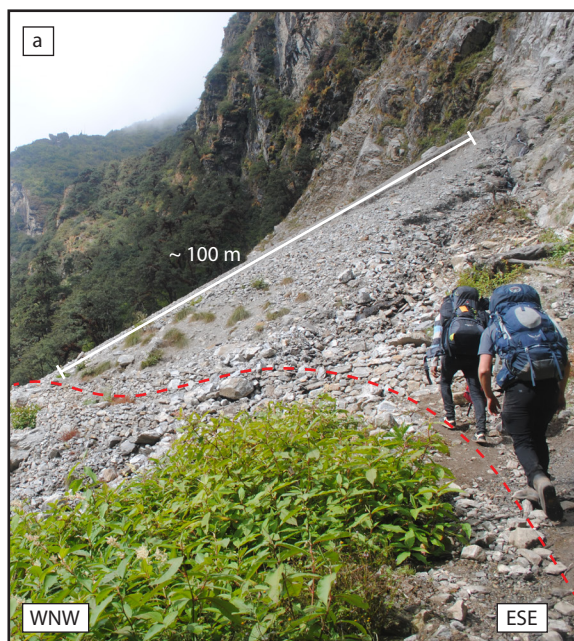
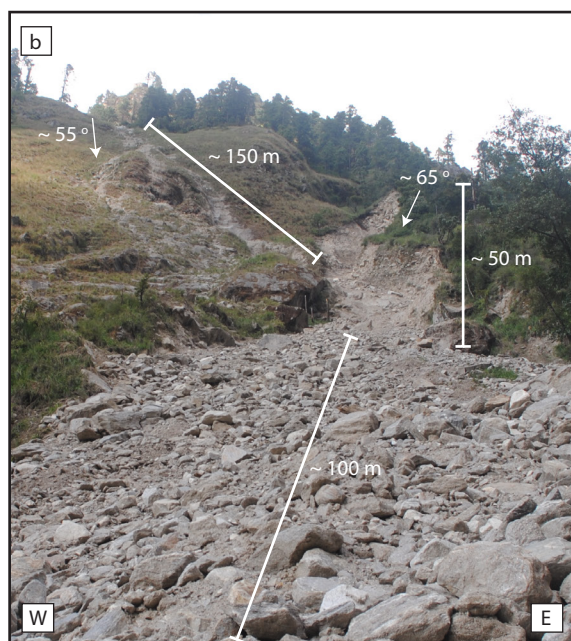
Fig. 7. (a) Debris fan of an unconstrained rockfall located ~ 4 km west of Thangsyap, which has intersected the trekking path (red-dashed line) below. **(b)** Debris fan of material from a debris flow and rock/debris fall that also intersected the trekking path (from where this photo was taken).

Unconstrained rockfalls were frequently observed to bury the main trekking route. Fig. 7a shows an example of such an event. The material in the deposits confirm that this failure occurred within the bedrock itself, which was composed of the unit 1 gneisses. The material from this failure buried a 30 m

long segment of the trekking path, reportedly killing 30 people. This landslide demonstrates that even relatively small-scale events have the potential to cause loss of life when hazard overlaps with vulnerability. Since the initial failure, a new trekking path has been re-dug through the deposits, with no attempt at any mitigation against potential monsoonal reactivation of debris material. As such, this section of the path should be considered at high-risk of being damaged or blocked by reactivated landslide material in the future. Fig. 7b shows a debris fan from a combined rock/debris fall and a rock/debris flow. The source zones for the flow and the fall appear to be at major $> 55^\circ$ and $> 65^\circ$ breaks in slope. The path of the flow appears to have been controlled by the existing hillslope morphology, with a knoll splitting the flow into two channels just before the main rockfall debris fan. The flow travelled for ~ 200 m before joining the main debris fan, whilst the debris from the main rockfall travelled ~ 100 m. This failure totally buried a ~ 40 m section of the trekking path, and is reported to have killed 20 people. Similar to the previous examples, the position of the new trekking path now lies on top of the landslide deposits, with no measures aimed at moderating future instability. As such, this section of the path is again considered to be at high risk of being blocked, or otherwise impacted, by future reactivation of landside debris.

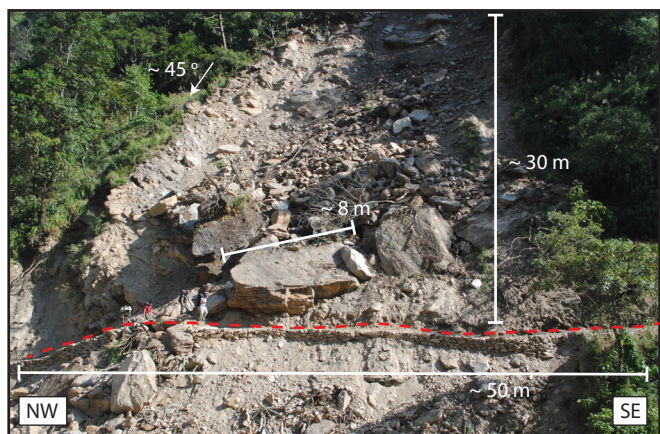
Fig. 8. Monsoon-triggered translational slide located 2 km east of Syraprubesi. A new trekking path (red-dashed line) has been constructed through the deposits, yet many large unstable boulders remain above the path.

As well as coseismic landslides, monsoon-triggered landslides were frequently observed across the valley, and care must be taken when distinguishing between these different triggering mechanisms. Fig. 8 shows a typical monsoon-triggered translational debris slide that has occurred on a forested, $> 45^\circ$ hillslope. This slide has a height of ~ 30 m, and completely destroyed an ~ 45 m wide section of the path below, which has since been re-built. The sides of the new path have been supported with small, < 0.5 m high walls of unconsolidated debris material. The debris material remaining above the new path is highly unstable, with several (> 10 m wide) blocks balancing within the deposits. This material will be highly susceptible to movement during subsequent monsoon-seasons, and as such remains at-risk of impacting the trekking path further.
